ENGINEERING ASSESSMENT OF GRANTHAM CANAL BETWEEN LOCKS 16, 17 & 18.

20 April 2010

ENGINEERING ASSESSMENT REPORT - 16/02/10.

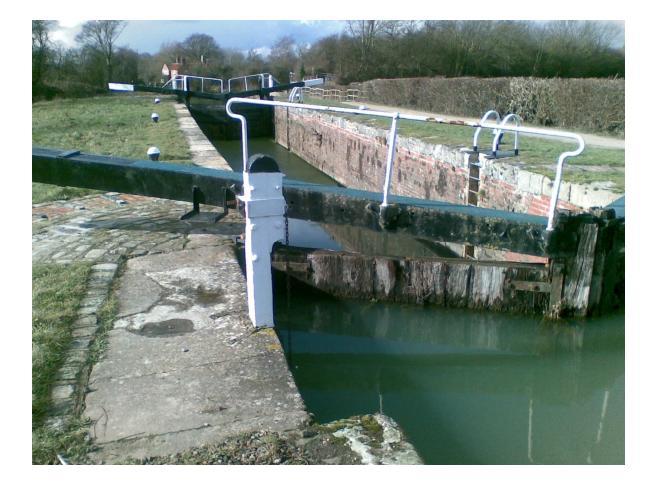
Lock 18

Woolthorpe Top Lock, Lock 18: GR-007-001

Condition Grade: C - Fair Consequence of Failure Grade: 1 – Single Minor Injury Serviceability Grade: 1 – Fit for purpose (as a remainder lock)

- The top and bottom gates are life expired and will need to be replaced (Notification 10834968).
- The balance beams need to have handles securely fitted (Notification 10937882).
- A new lock ladder needs to be fitted in the offside recess (Notification 10548801).
- The upstream stop planks need to be removed
- The offside crack needs to be monitored.

The estimated cost of these works is £120,000 based on the typical cost of lock gate replacement schemes (and associated works) in the East Midlands.

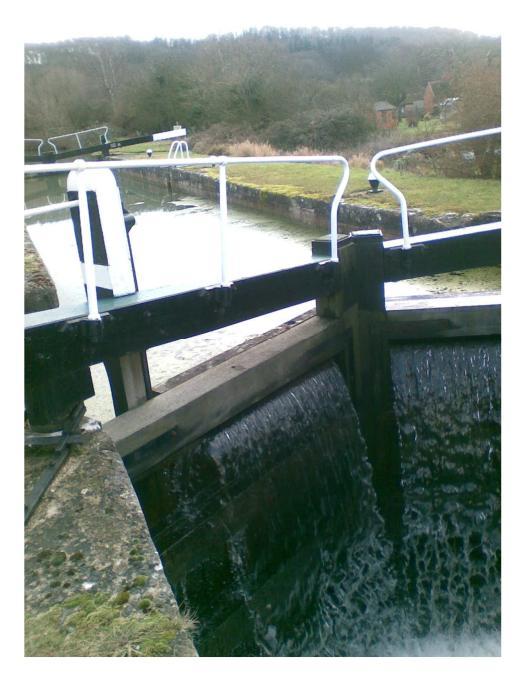
Lock 17

Woolthorpe Middle Lock, Lock 17: GR-007-003

Condition Grade: C - Fair Consequence of Failure Grade: 2 – Minor Injuries Serviceability Grade: 1 – Fit for purpose (as a remainder lock)

- There is water leakage through and around the lock chamber walls and needs to be grouted to prevent future leakage (Notification 10086367).
- There is a large pisser situated behind the offside lock ladder recess indicating a large void behind the wall. This will need to be grouted to prevent fines from being washed away (Notification 10834969).
- The balance beams need to have handles securely fitted (Notification 10937880).
- Steel lined stop plank grooves need to be installed to aid future maintenance (notification 10548800). These works are not urgent but should be considered if the canal is dewatered.
- General vegetation clearance on the offside will be required.
- The offside top quadrant will need to be extended to ensure safe use.

It is estimated that works to this lock would cost £25k for grouting, £1k for balance beams, £5k for stop plank installation and £1k for offside quadrant. The estimated cost of the remaining works is minimal if the works can be carried out by volunteers.

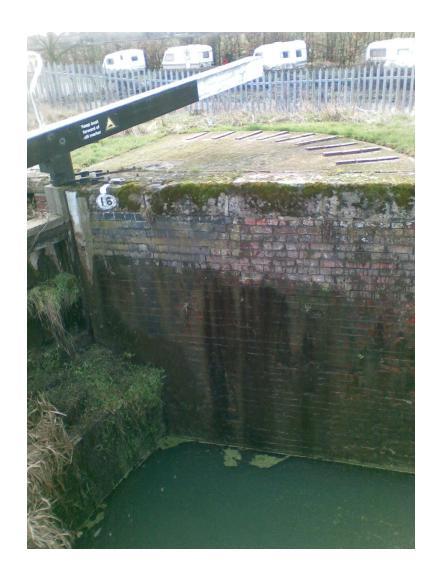
Lock 16

Woolthorpe Bottom Lock, Lock 16: GR-007-006

Condition Grade: D - Poor Consequence of Failure Grade: 1 – Single Minor Injury Serviceability Grade: 1 – Fit for purpose (as a remainder lock)

- There is water leakage through and around the lock chamber walls at both the upstream and downstream gates; this needs to be grouted to prevent future leakage. There is also a large bulge and cracked brickwork in the offside downstream approach wall; this will need to be taken down, rebuilt and possibly anchored back before the wall is grouted (Notification 10570108).
- The balance beams need to have handles securely fitted (Notification 10937878).
- Vegetation needs to be removed from behind the top gates and from the downstream towpath side quadrant (Notifications 10834970 & 10700355).
- There is a leak from beneath the downstream gate sills which needs to be repaired to allow the lock chamber to hold water (Notification 10347339).

It is estimated that grouting works to this lock would cost approximately £35k. Re-building the approach wall would cost in the region of £10k and the sill works would be approximately £10k. The estimated cost of the remaining works is minimal if the works can be carried out by volunteers.
