Grantham Canal EcIA:
Bat nursery house

Figure 5:	Date: May 07
Scale: Schematic	ECUS Ref: NB.0528.Fig5

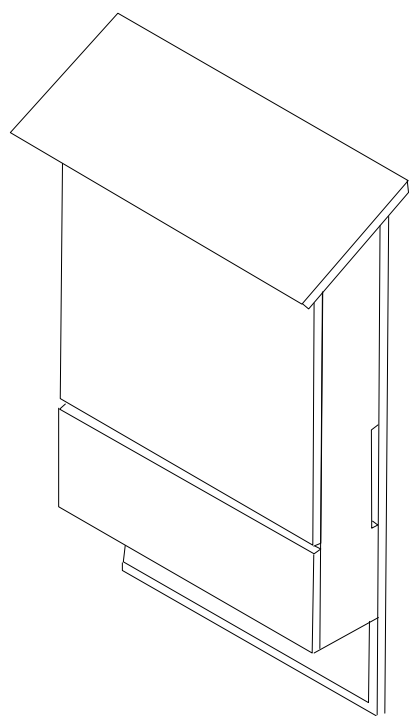
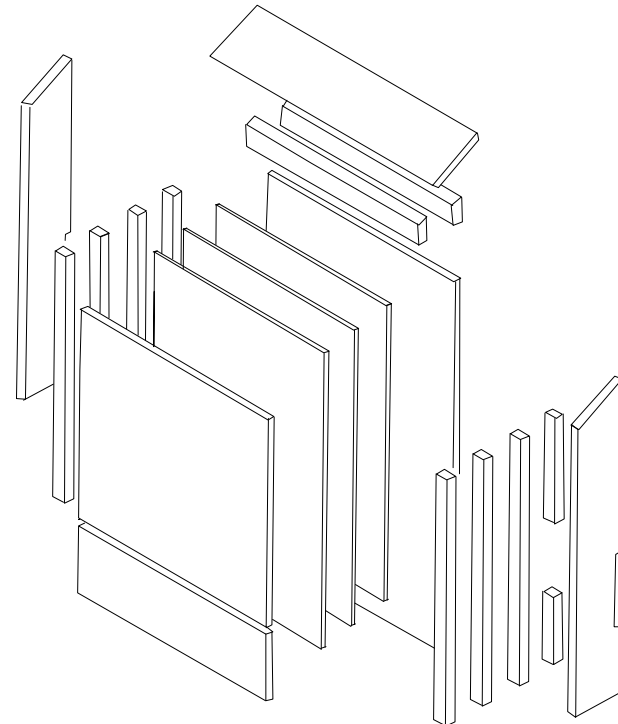
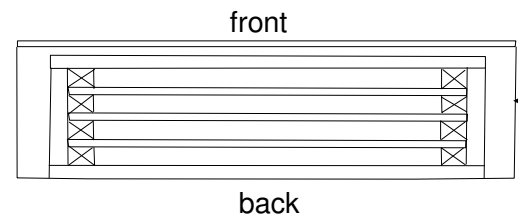
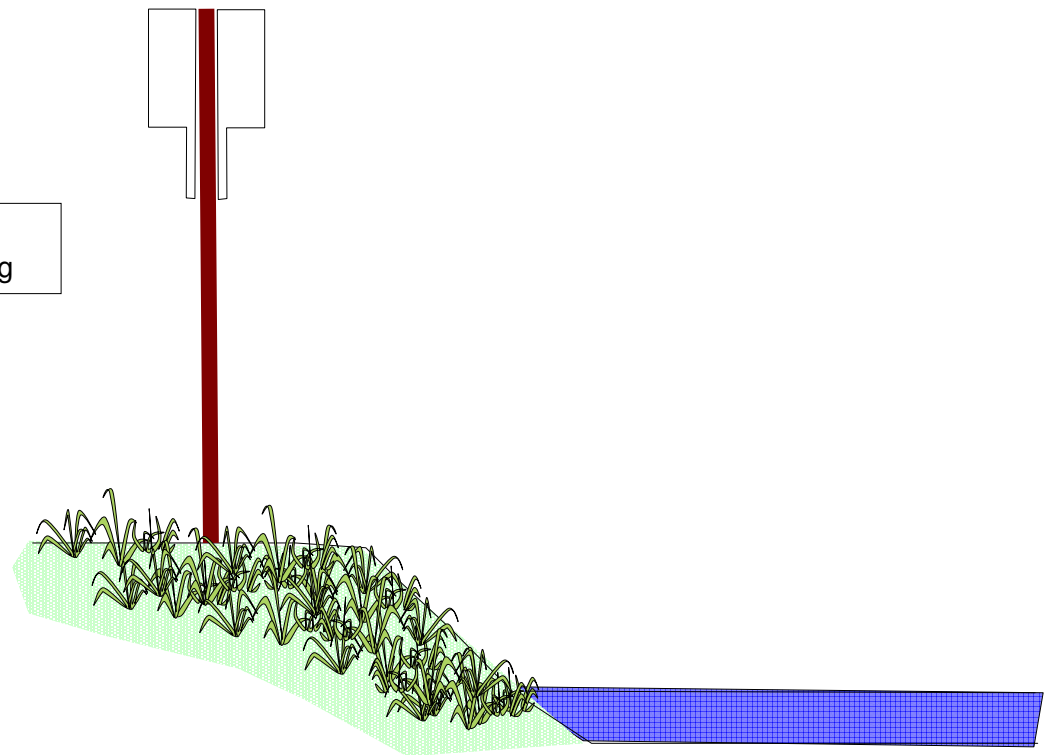
Roof supports

$\frac{3}{4}$ " spacers

Front vent

$\frac{1}{2}$ " side vent

Landing area

Side view

Bottom View

front

back

roof overhang
